East – West Rail: Phase 1

Chiltern Railways Company Limited

Vibration from Switches & Crossings – Assessment and Mitigation

5114534-ATK-VIB-RPT-80003
Revisions A01

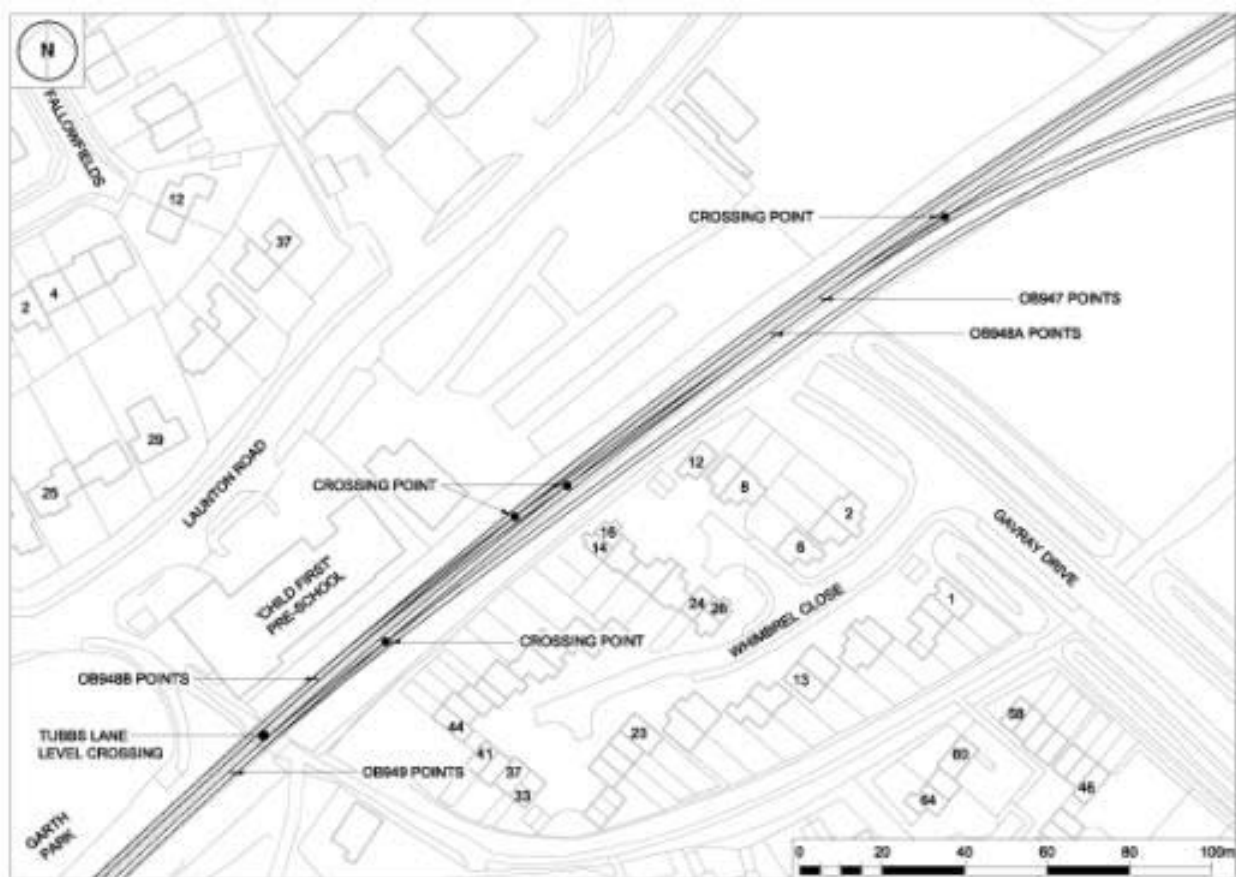
Figure 1. Switches and Crossings near Whimbrel Close

- No.16 at Whimbrel Close – 12.5m from crossing point 1, 21.8m from crossing point 2
- No.4 at Bladon Close – 19.2m from crossing point
- No.21 at London Road – 11.2m from crossing point 1, 17.0m from crossing point 2

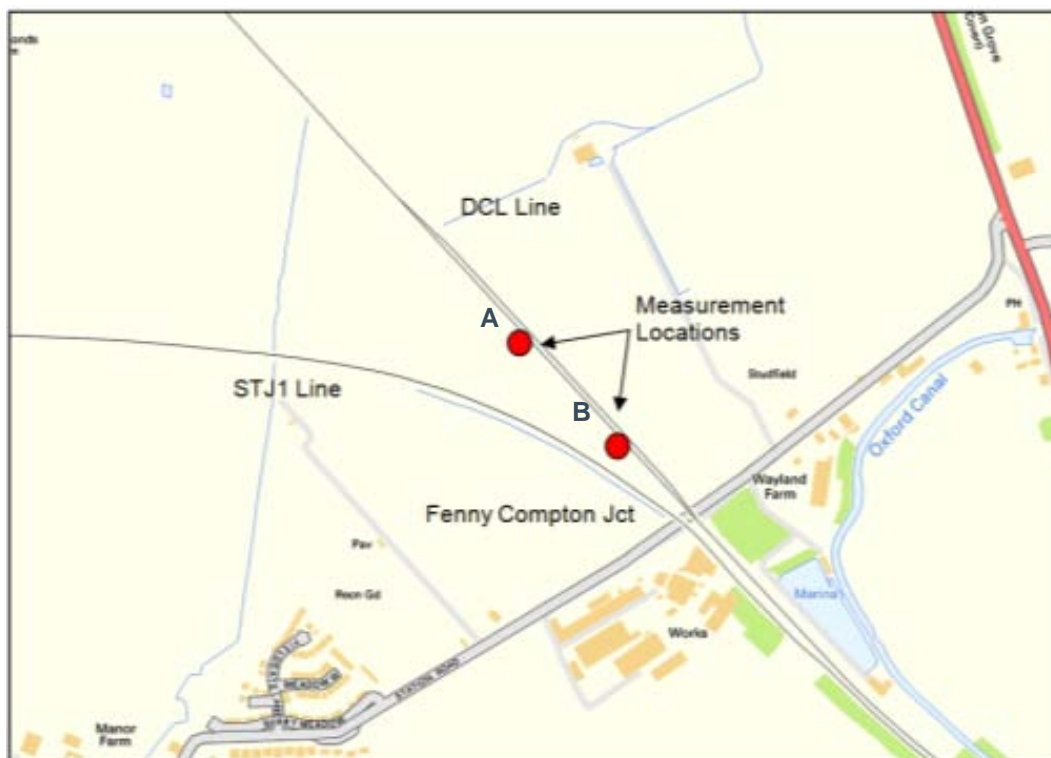
Figure 4. Vibration Monitoring Locations at Fenny Compton

- 3.4. The Fenny Compton Junction North was the only suitable accessible site with similar underlying geology (Charmouth Mudstone - stiff silty clay/blue lias), sufficient space to undertake the simultaneous vibration measurements and no site restrictions such as cuttings or features which would affect vibration measurements. The approximate location of the measurement site is shown in Figure 4 below.

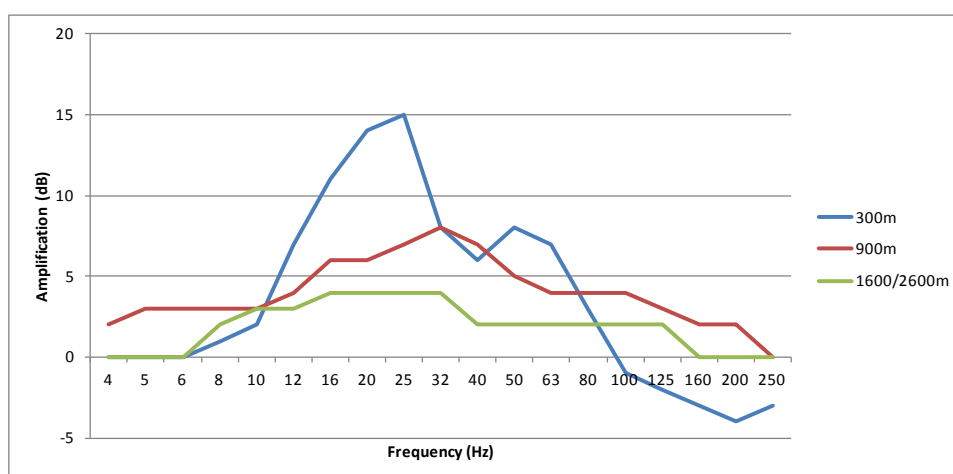
Figure 10. Turnout Amplification with Radius (RIVAS project)

- 4.4. Average values of turnout amplification (TA), in dB, derived from a number of measurements are shown below for various turnout types (radius). The reference track was at grade and comparisons relate to a distance of 8m from the track.

- 4.5. As shown above, the smaller the turnout radius, the higher the amplification caused by the crossing point. The frequencies affected were typically between 12.5Hz and 63Hz.

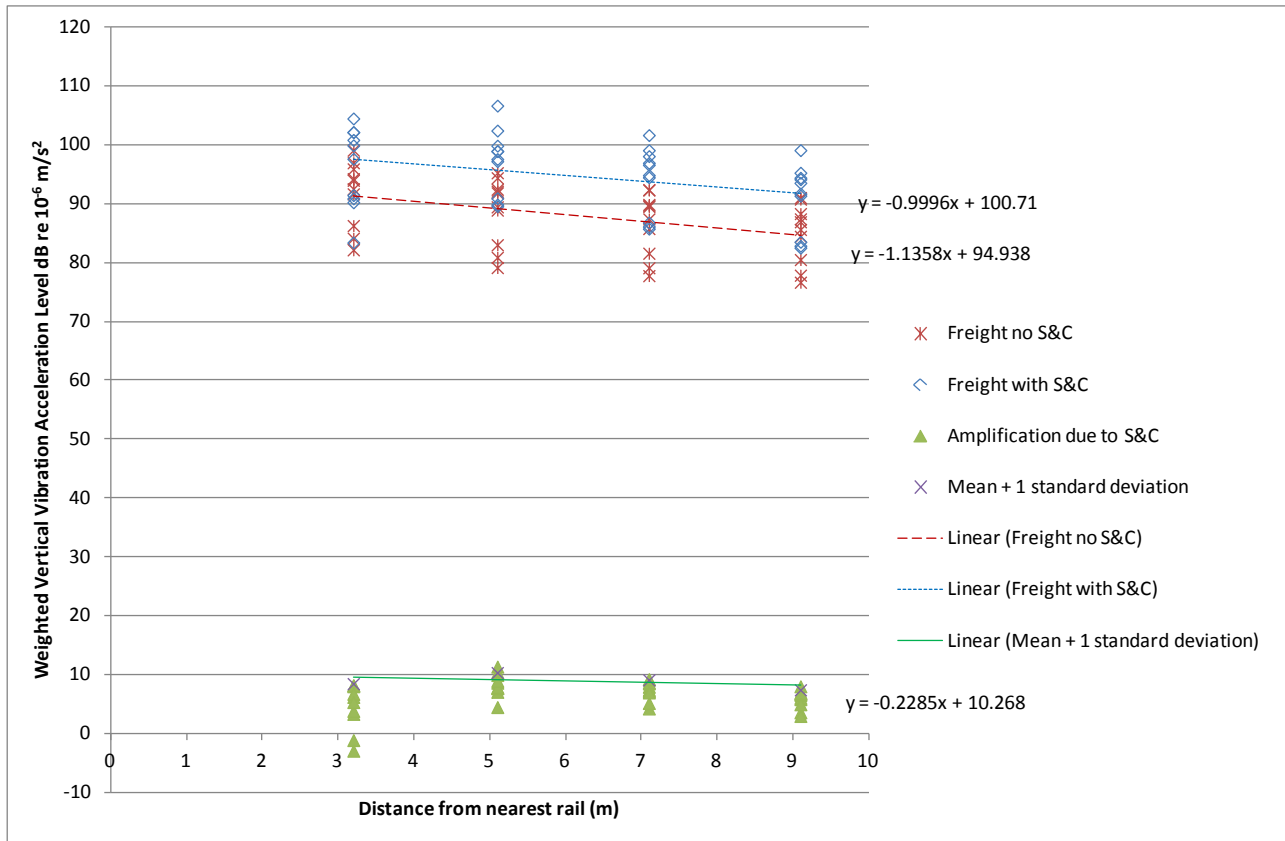
Figure 11. S&C Amplification due to Freight trains

- 4.14. In this section, only the pass-by events observed on the nearest track (track 1) have been described. The measured dB weighted acceleration level re 10^{-6} m/s^2 , are shown against distance from nearest rail, along both the S&C and the plain line sections of the track. The difference between the levels for each pass-by event is identified as an amplification factor in dB, due to the presence of S&C. Figure 11 and 12 illustrate this information for freight and passenger trains respectively.

- 4.15. The highest amplifications are noted to be between 5.1m and 7.1m from the track depending on the vehicle type. At 9.1m from the track, the amplification in overall weighted acceleration vibration levels is approximately 8dB for freight trains and 11dB for passenger trains. This is consistent with published guidance values of 10dB (or a factor of 3.16) by FTA [4].

- 4.16. On average, the amplification factors were found to decay at a rate of approximately 2dB every 10m from track for freight trains and 1dB for every 10m from track for passenger trains. This distance relationship is similar to the findings of the RIVAS study which observed a decay rate of around 1dB for every 10m between 8m and 35m from track.

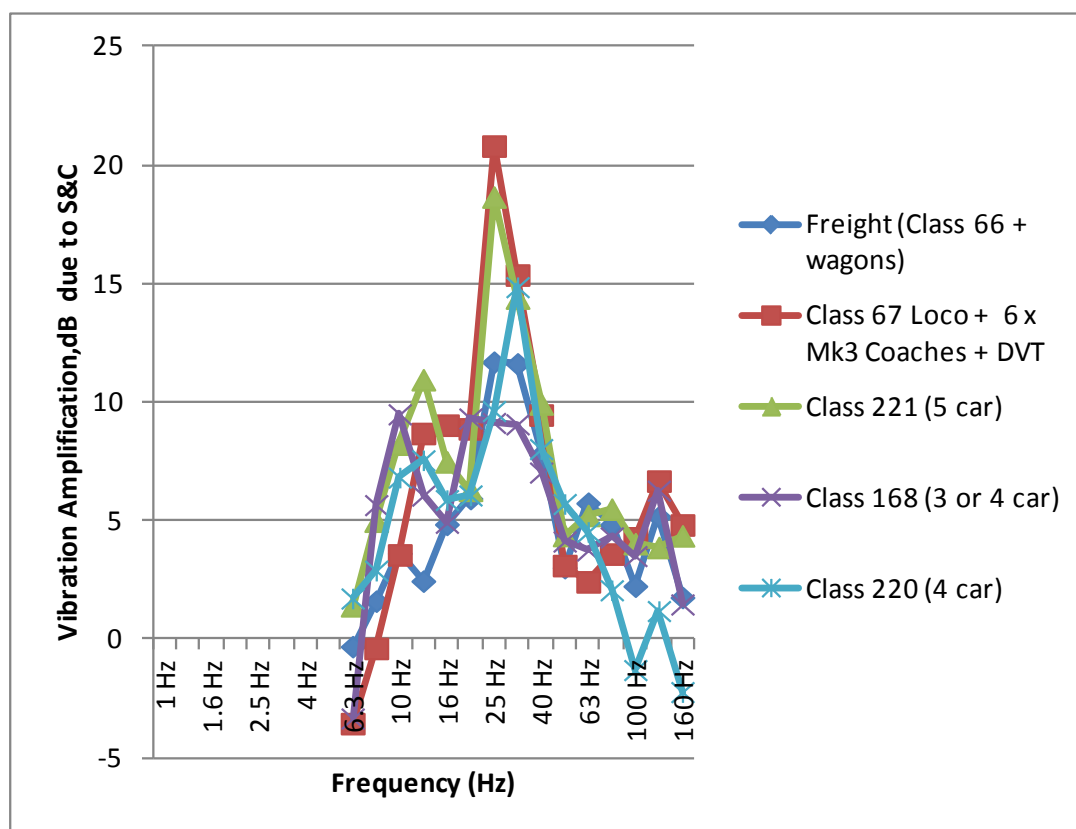
Figure 13. Average vibration amplification at 9.1m from track 1 for different types of trains

- 4.22. At 9.1m from the track 1, significant amplifications were observed at mid-frequencies of 25Hz and 31.5Hz. The highest amplifications were generated by the 8-car Chiltern trains (comprising Class 67 locomotive + 6 x Mk3 Coaches + DVT) and the Class 221 (5-car) trains. The amplification from Class 220 and Class 168 trains were noticeably lower. It was also observed that the amplifications from the freight trains (with varying number of wagons) were generally similar to those from Class 220 trains.

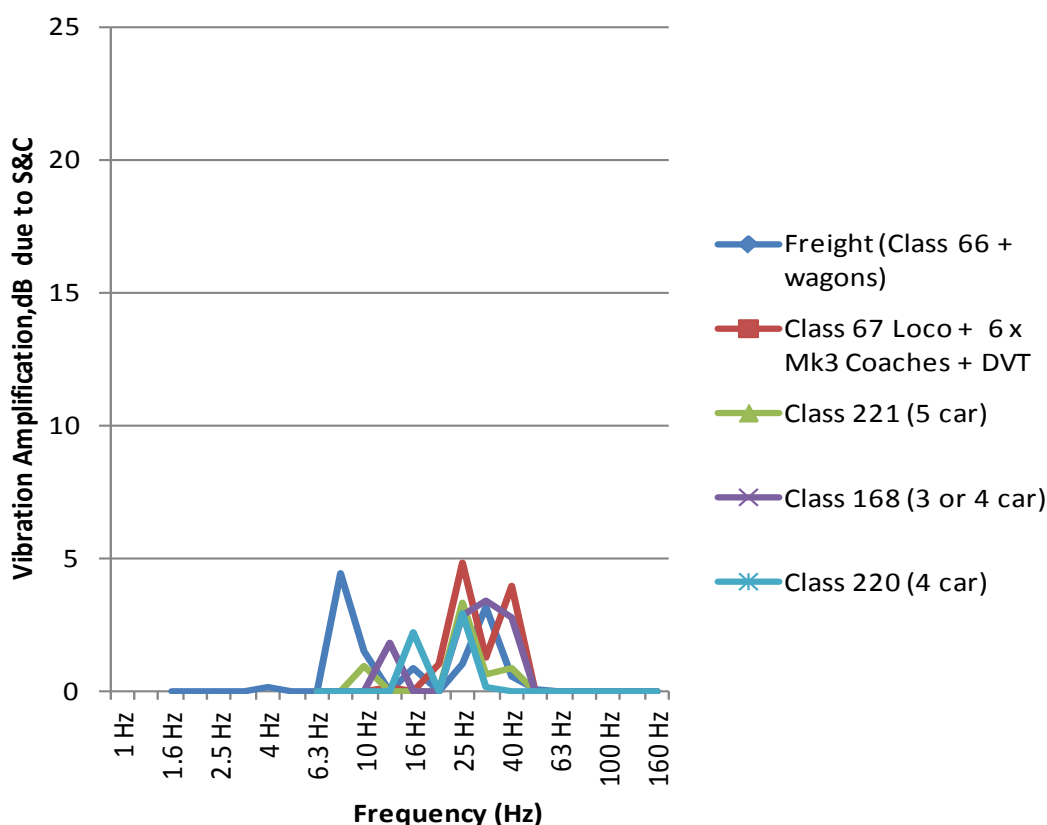
Figure 14. Average vibration amplification at 13.7m from track 2 for different types of trains

- 4.26. At 13.7m from the track 2, amplifications were observed at 25Hz to 40Hz. A peak was additionally observed at 8Hz for the freight trains. However the magnitude of the peaks was significantly lower (less than 5dB) compared with amplifications near track 1.

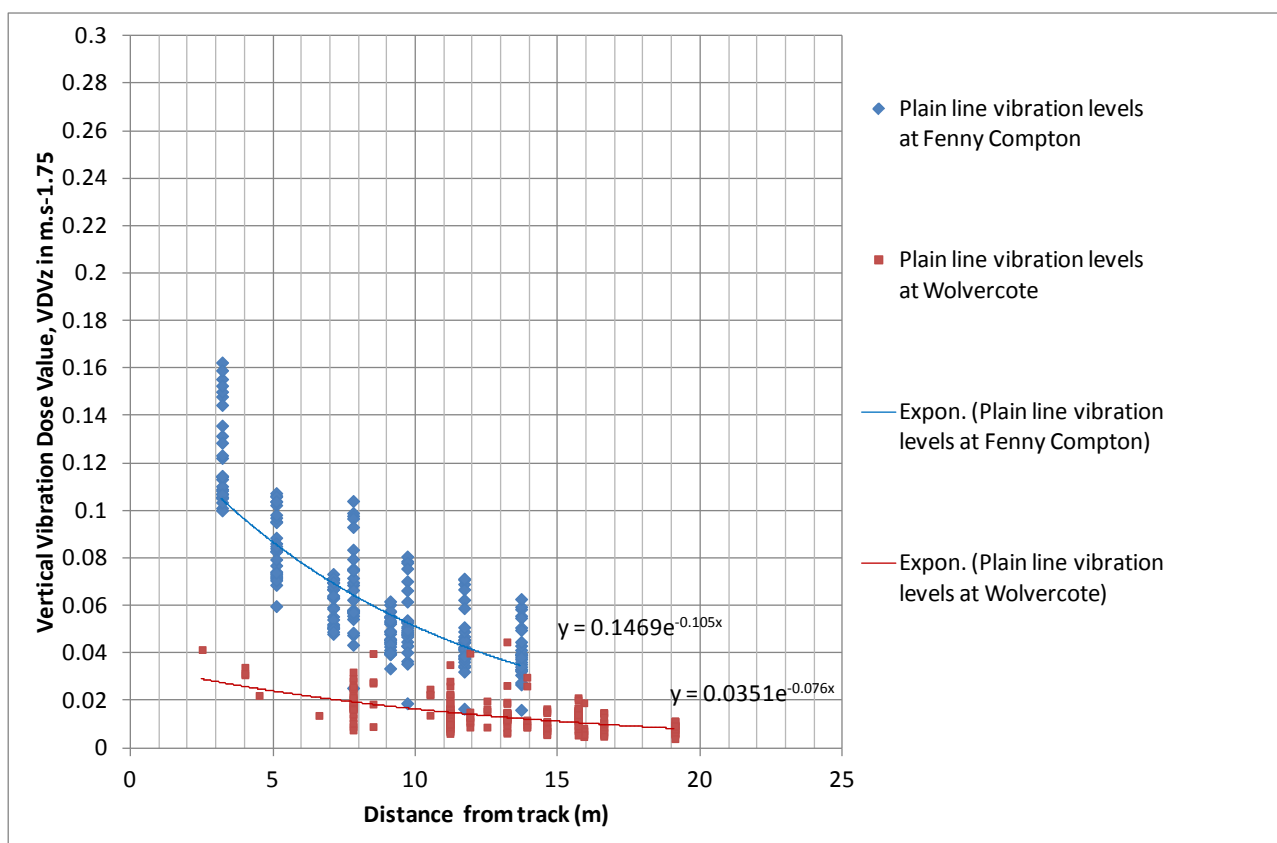
Figure 15. Vibration Measurements at Wolvercote and Fenny Compton

4.29. It is shown that the plain line measurements at the Fenny Compton site are higher than the measurements at Wolvercote. At about 11m (typical distance between nearest property and the crossing point), the difference can be as high as a factor of three. This difference would then be reflected in the measurements undertaken near the crossing point. It is noted that these measurements have not been normalised for speed, and some of the discrepancy could be explained in terms of variation in train speeds.

4.30. Based on the observed differences between measurements at Wolvercote and Fenny Compton sites, it would not be appropriate to use the absolute levels measured near the S&C directly to estimate project VDVz. It is considered that, within the Fenny Compton site, the measurement positions near the crossing point and the plain line section of track 100m away share the same local geological characteristics. Both sets of measurements would be equally affected and the

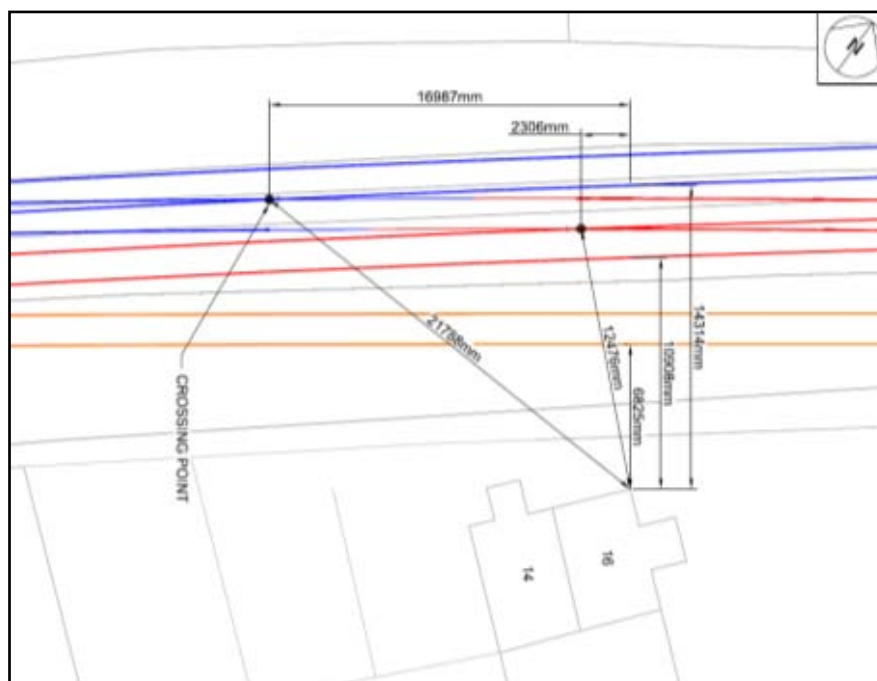
Figure 16. Proposed Site Geometry at 16 Whimbrel Close

- 5.4. Step 3 - The amplification factors are adjusted for distance using the amplification decay relationships derived previously. The distance between the receivers and tracks/ crossing points are illustrated below for 16 Whimbrel Close, 4 Bladon Close and 21 London Road. This accounts for distance effects, however the effect of extra formation (i.e. the proposed chord line) is not taken into account.

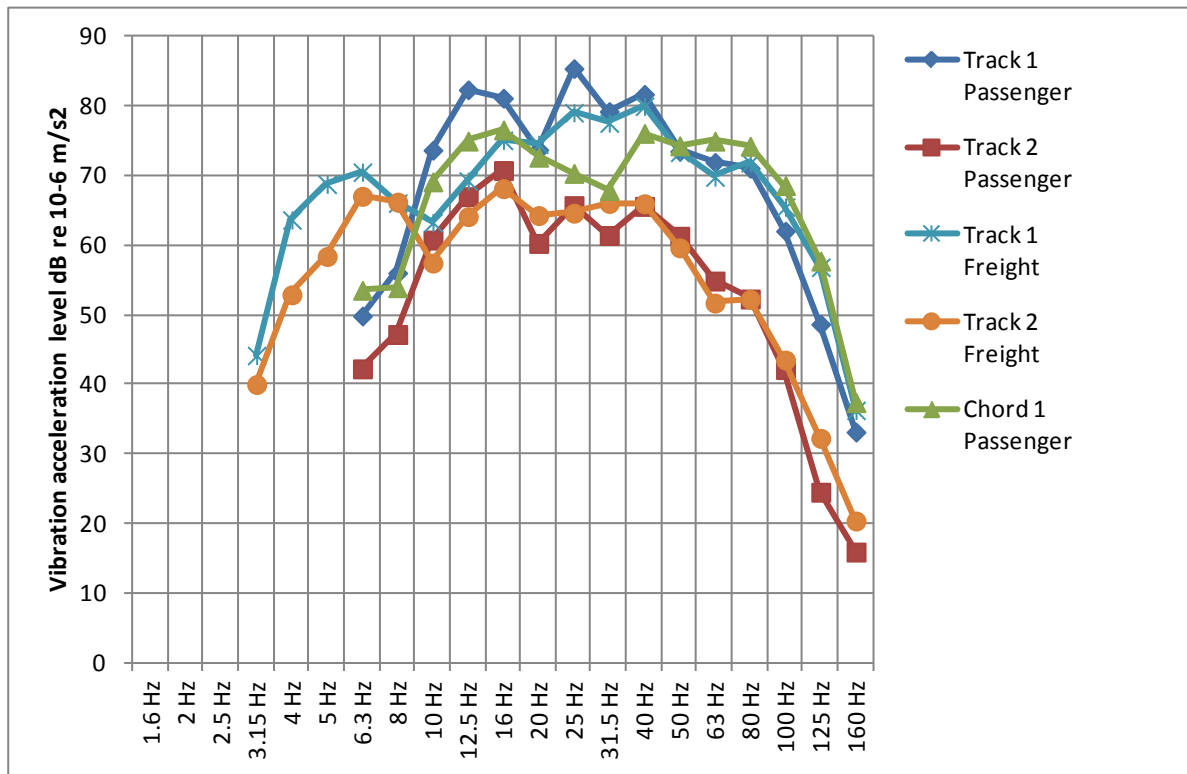
Figure 20. S&C vibration levels at 16 Whimbrel Close

- 5.9. The highest component of VDV would be the passenger trains on track 1 (nearest track). The vibration levels at 25Hz are shown to be highest.
- 5.10. The calculated levels represent a reasonable worst-case since it is assumed that;
- passenger trains in the future would entirely consist of Class 221 trains, which result in higher levels of vibration amplification over a crossing point compared with Class 168 and Class 220,
 - the beneficial effect of extra formation (i.e. due to the presence of chord line) between track 1 and the receivers is not taken into account at Whimbrel Close.

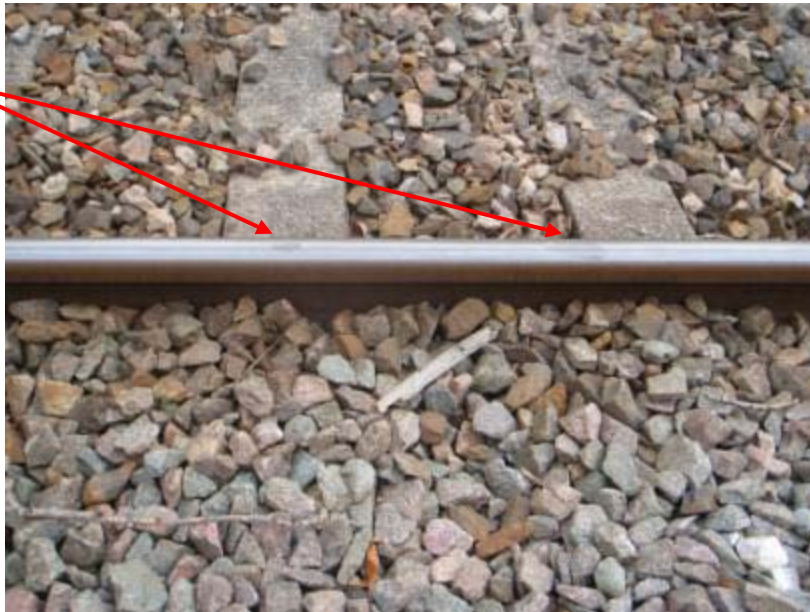
Photograph 3: Shadowing on right hand rail facing Oxford

The Up rail (right hand rail looking towards Oxford) at the vibration monitoring location, showed signs of “shadowing” or a local “squat” developing, see photograph 3. However, no surface “breaking out” had started to occur and when the site was witnessed under dynamic loading, no noticeable change in noise was noted.

“Shadows”/“squat”
on the Up rail

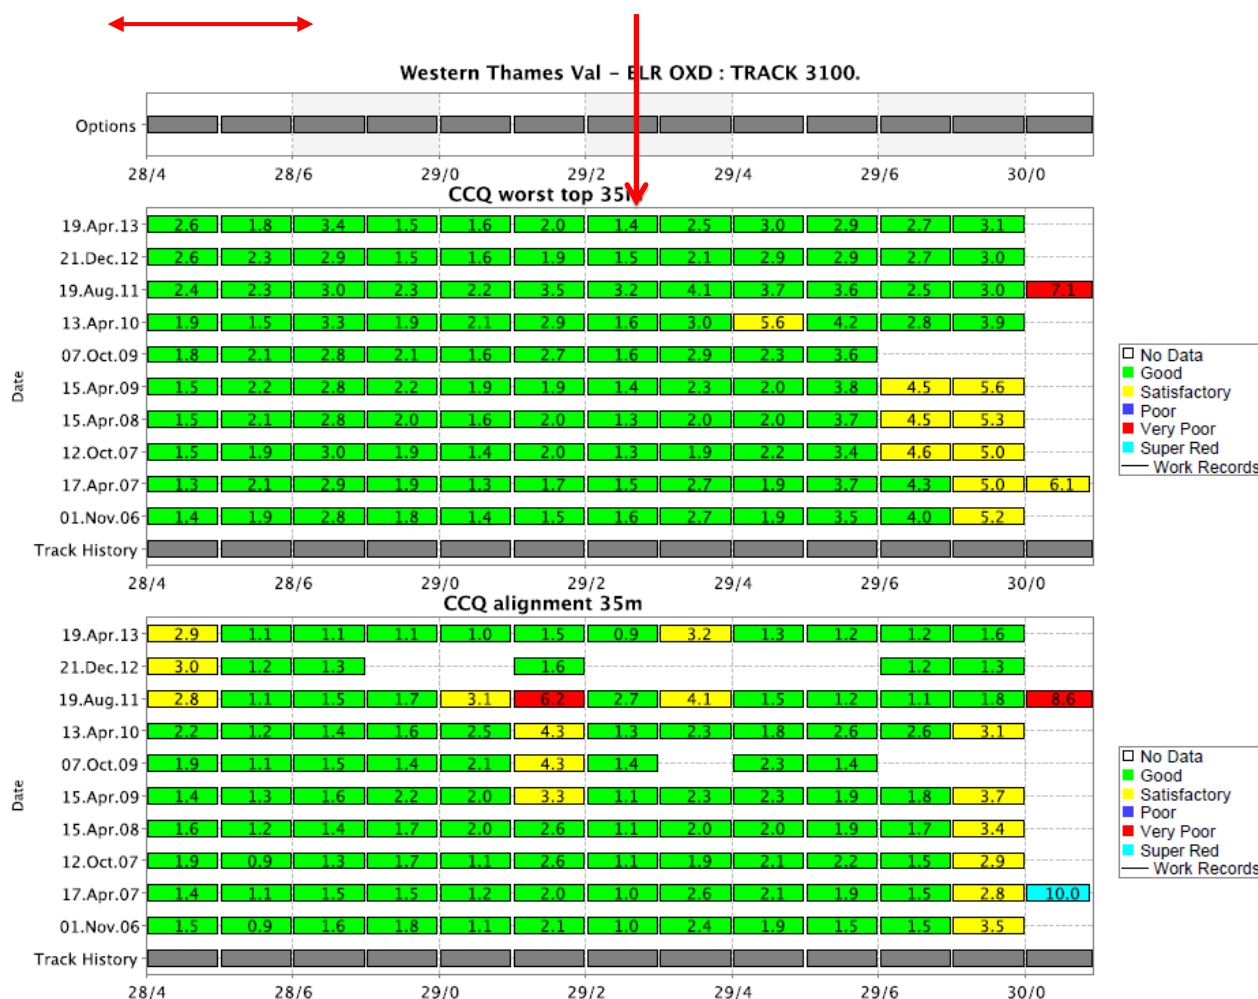
Figure 3: Track Recording Vehicle Track Quality Data

The data clearly shows that for April 2013, that between the 29/2 (29m ¼ milepost = 20chains) and 29/4 (29m ½ milepost = 40chains) that the horizontal alignment is in the good quality band. It can be seen that on the vertical alignment that the 1/8th mile band prior to 29/4 is in the satisfactory band. This is due to the vertical alignment at the under bridge OXD50 bridge ends. As highlighted in photograph 2 and section 2.1.1.

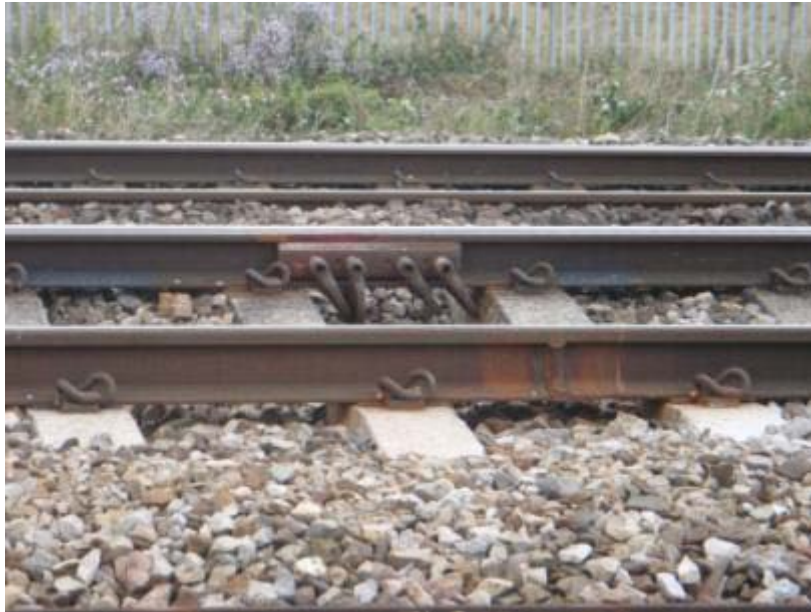
Photograph 10: DCL Line Up Main 6' rail 65m 515yards. Thermit Weld Emergency clamped

It was noted that on the Up Main, a thermit weld has been emergency clamped and that there was an L80 wide gap weld installed. There was no evidence of these causing any issues at present and under dynamic loading no excessive track movement or "banging" was noted.

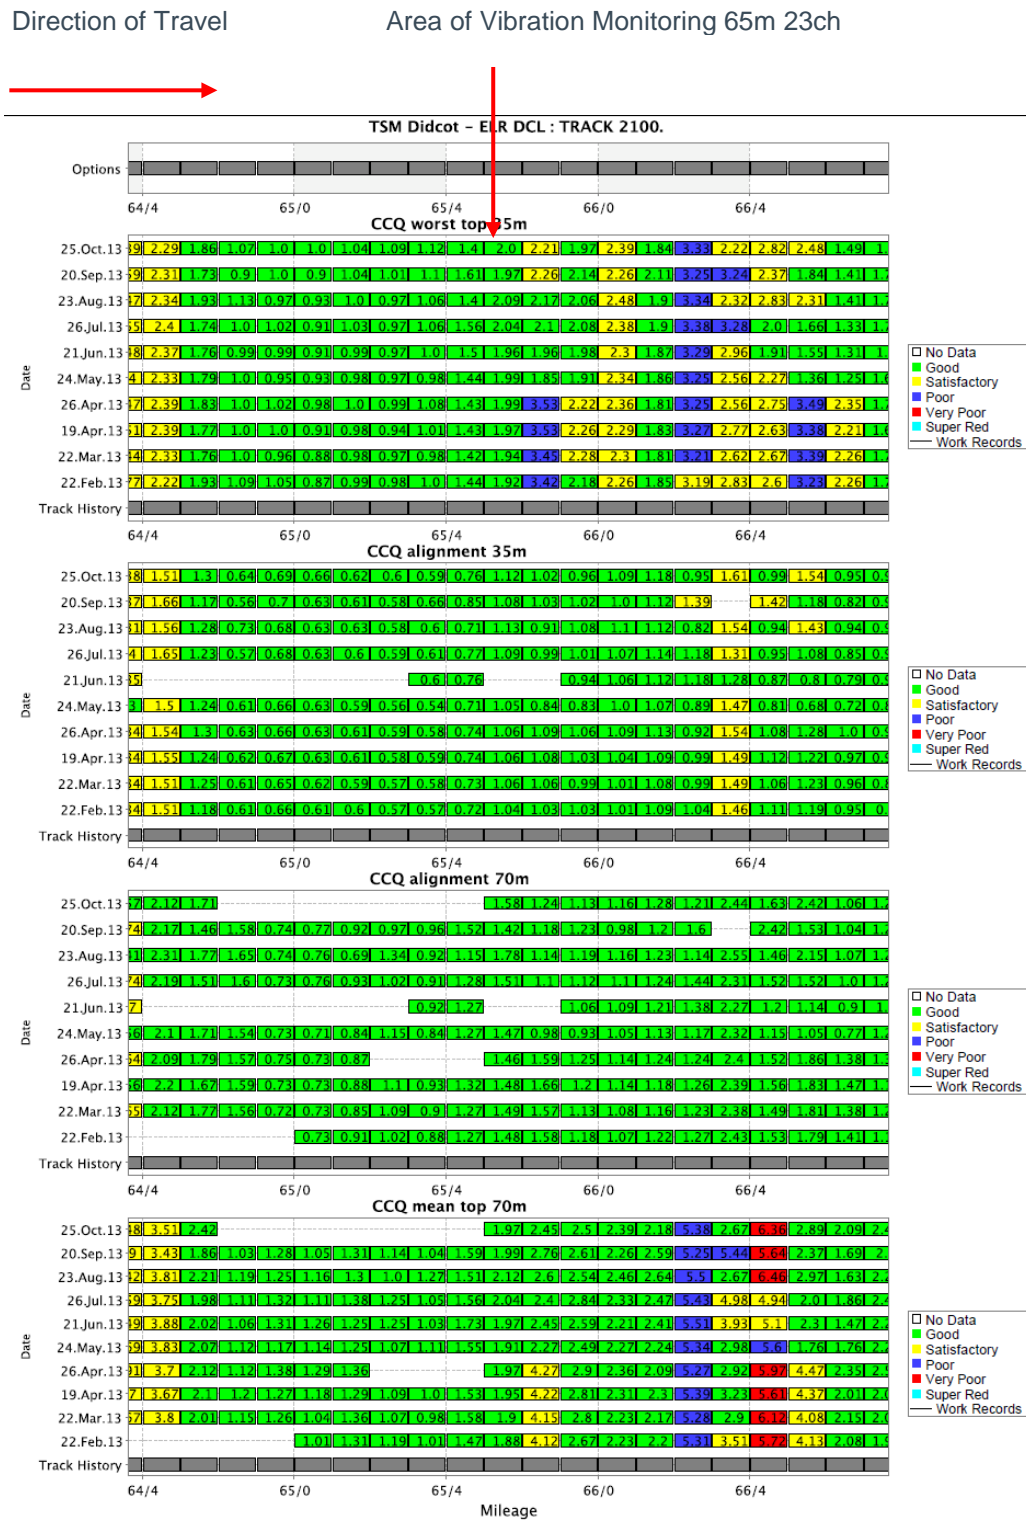
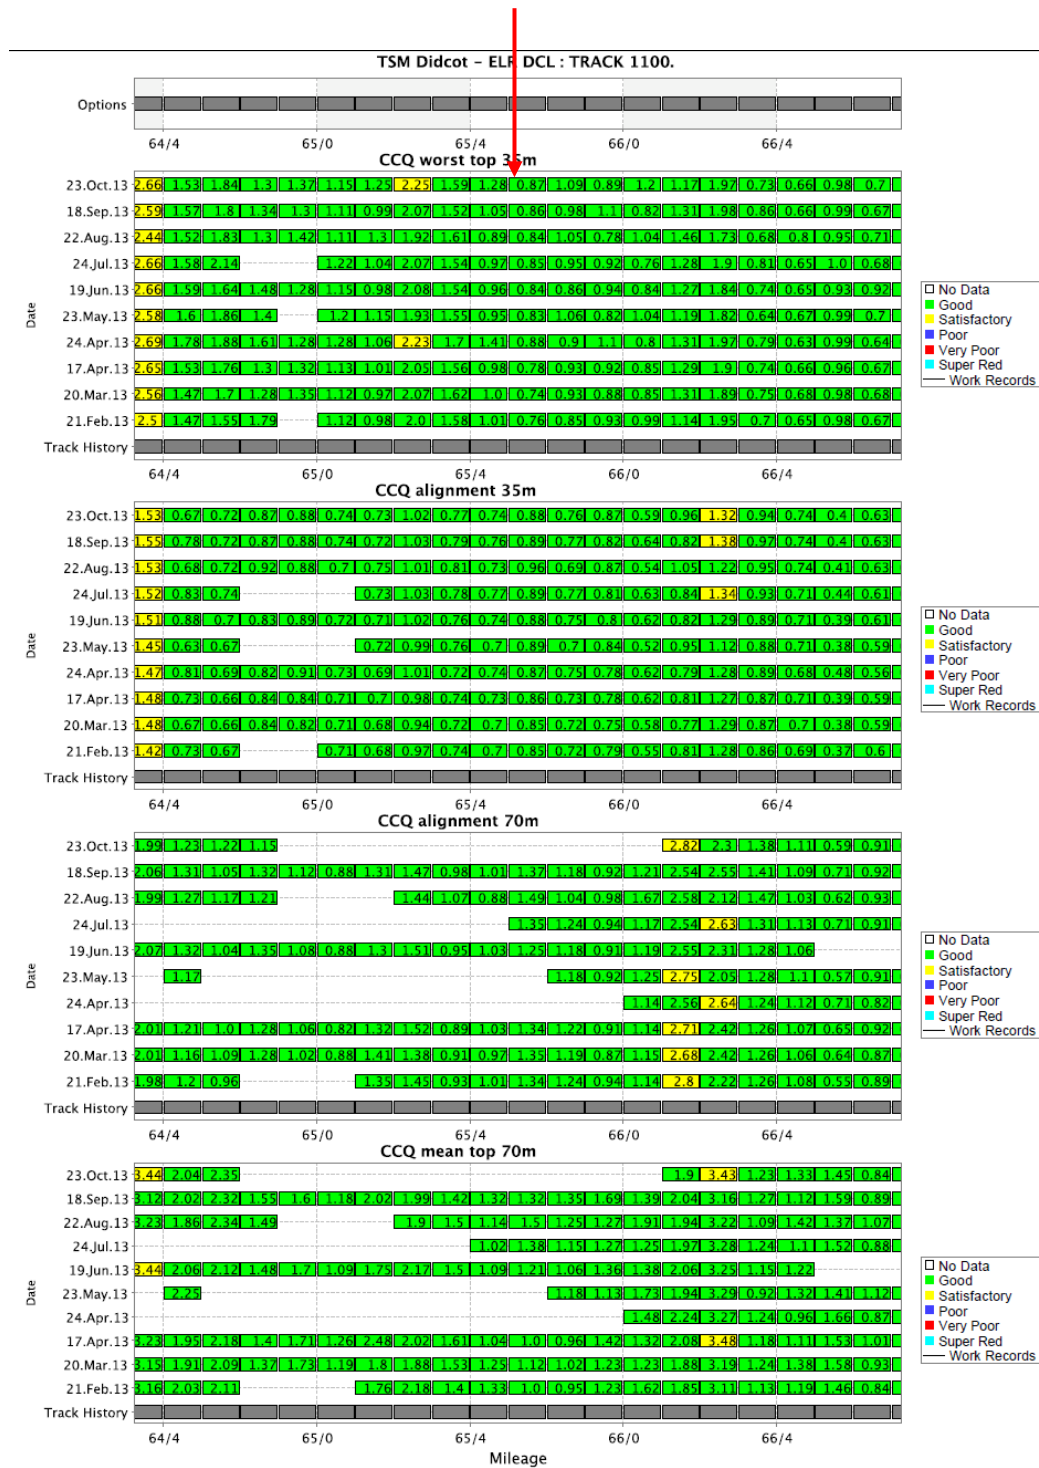
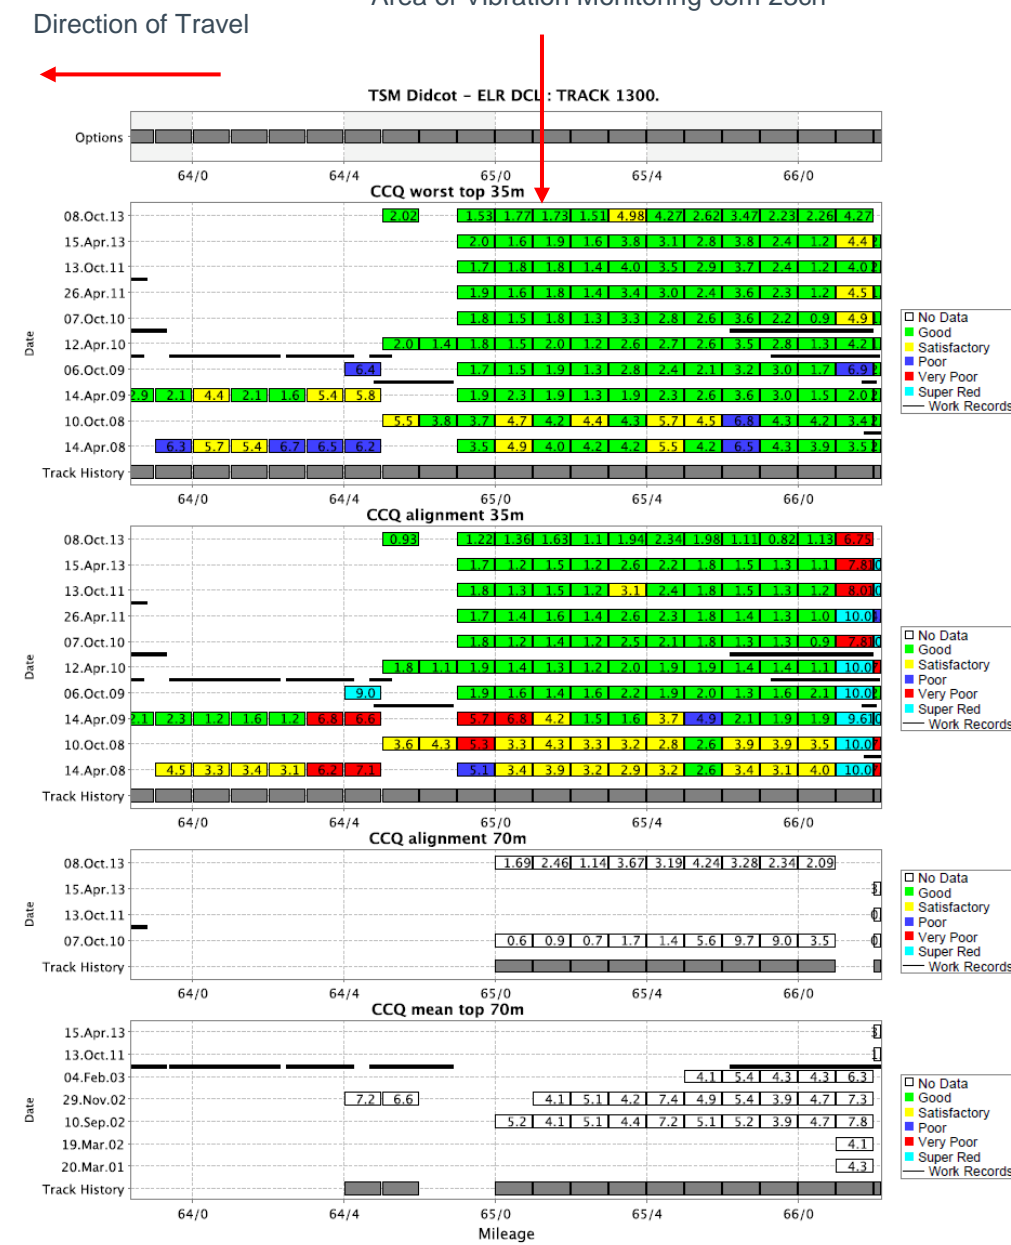
The latest available track quality data available from the track recording train can be seen in figures 6-7 below.

The track quality data indicates at the time of the survey, that on all lines and for horizontal and vertical alignment the track was in the “Good” band, this is confirmed from the visual inspections undertaken.

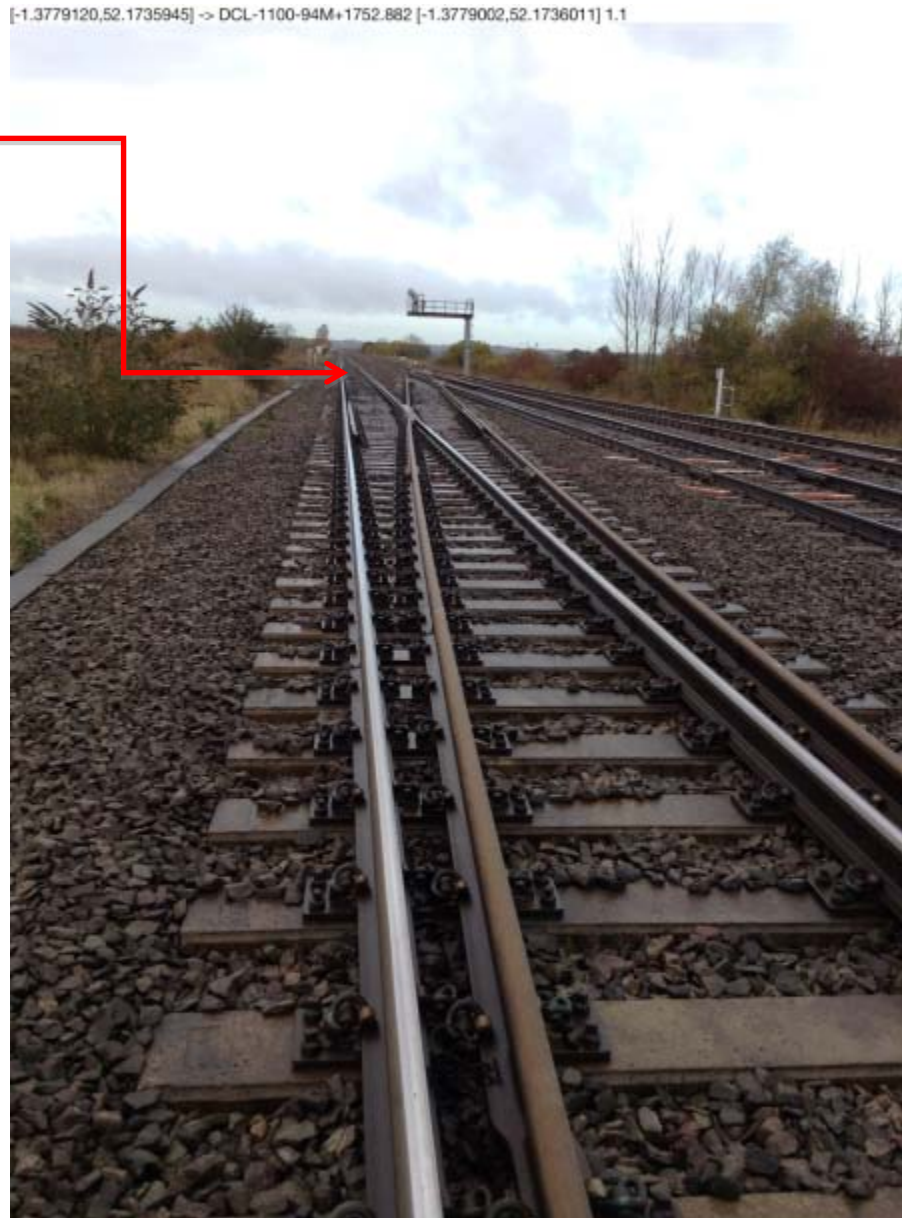
Photograph 12: DCL Line at 94m 79chain Looking towards Leamington Spa (direction of travel)

Long horizontal alignment fault on the Down main at approx. 95m 5-10ch

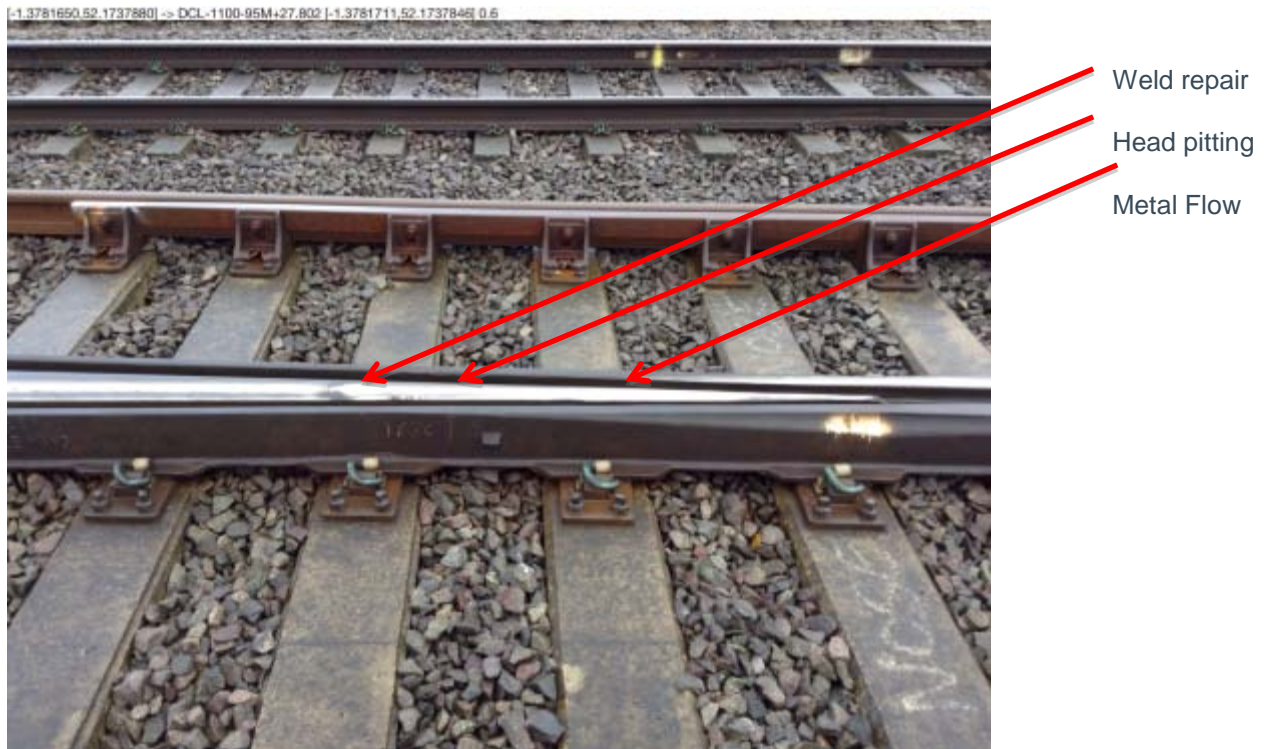
Photograph 14: 160 Points, Edgar Allen Cast Manganese Crossing

No evidence of “pumping” or excessive “banging” was witnessed under dynamic load, however, it is recommended that the crossing undergo some remedial grinding to restore the correct rail head and frog profile.

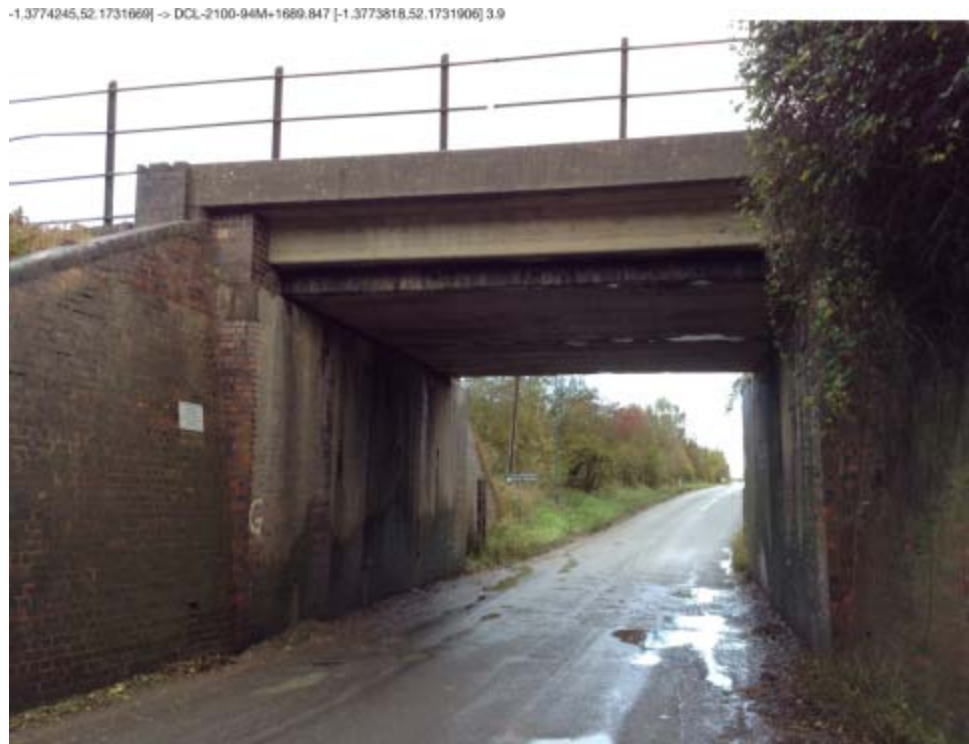
Photograph 15: Under Bridge 99, DCL 94m 77ch Western (Down cess) Elevation

Under bridge 99, is a precast concrete beam bridge on brick abutments and concrete cill beams. The bridge and abutments seemed to be in reasonable condition, and no major defects were noted as part of the inspection. The eastern elevation can be seen in photograph 15.
